# PARK RIVER LOCAL PROTECTION

## VOLUME II APPENDICES

REPORT DOCUMENTATION PAGE		READ INSTRUCTIONS BEFORE COMPLETING FORM
1. REPORT NUMBER	2. GOVT ACCESSION NO.	3. RECIPIENT'S CATALOG NUMBER
4. TITLE (and Subtitle) PARK RIVER LOCAL PROTECTION AS-BUILT FOUNDATION REPORT AUXILIARY CONDUIT TUNNEL		5. TYPE OF REPORT & PERIOD COVERED APPENDICES VOLUME II

17. DISTRIBUTION STATEMENT (of the abstract entered in Block 20, if different from Report)		
18. SUPPLEMENTARY NOTES  PARK RIVER AUXILIARY TUNNEL AS-BUILT FOUNDATION REPORT

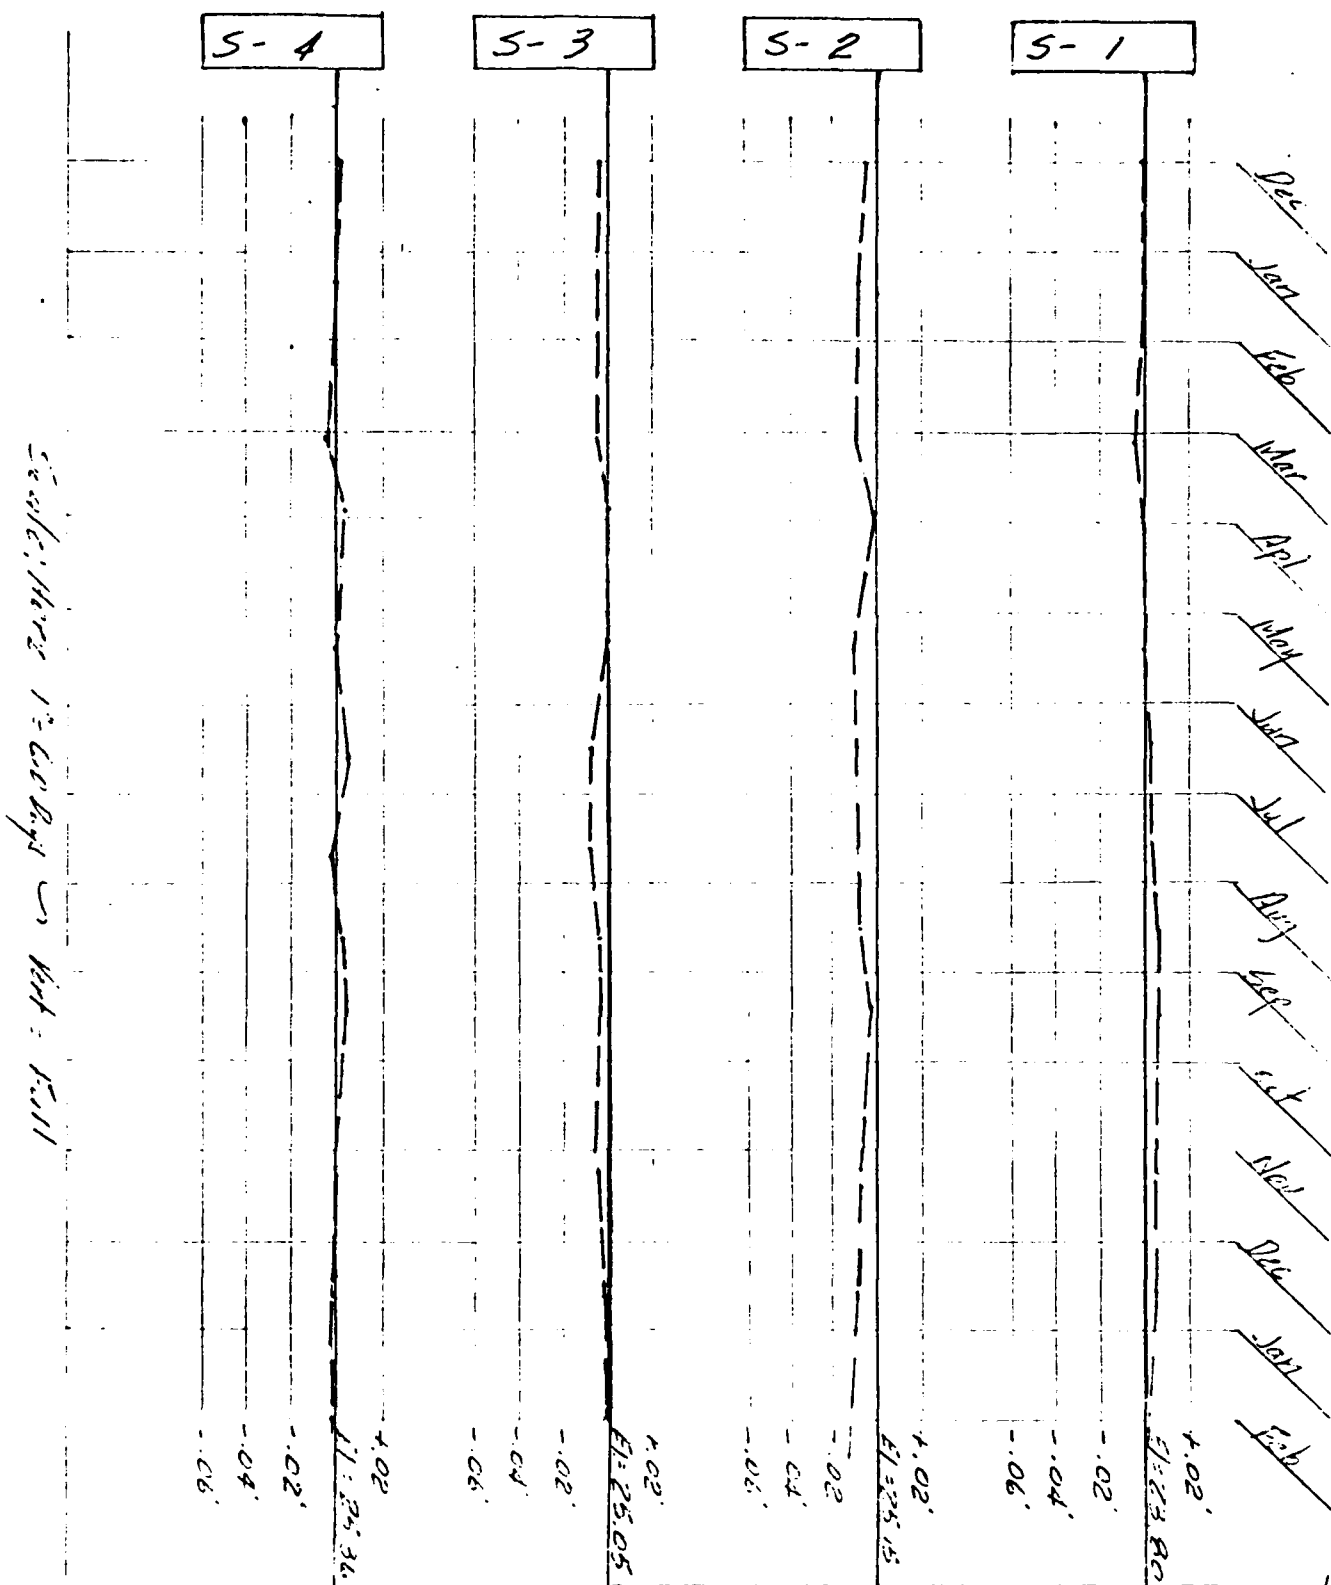
Park River Project  
Hartford Ct.  
Subsidence  
Survey

Mar 1979 to  
May 1980
